Management Survey for
MyTime Active
at
Barnehurst Golf Course
Mayplace Road East
Bexleyheath
DA7 6JU

Project Number: J013203

AC&MS Ltd (Asbestos Consultancy & Management Services)	Project Number:	J013203
	Survey Date:	23 Mar 2021
	Printed On:	29 Mar 2021
	Page:	Page 1 of 1

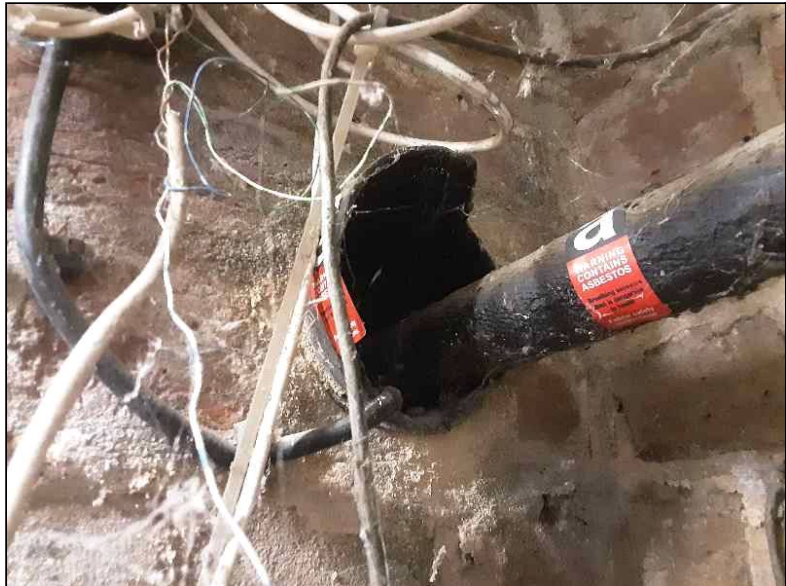
Item Ref:	2	Survey Type:	Management (MA + PA)
Sample Ref:	SO002542	Product:	Well Bound Material
Area:	Other	Product Type:	Low Fibre Release
Floor:	Z-Sub Level 1	Asbestos Type:	Chrysotile
Room:	Basement Lobby & Corridor	Damage:	Low Damage
Surveyor Name:	Craig Chapman,	Treatment:	Well bound materials
Identification:	Identified	Quantity:	11m
Asbestos ?	Yes		
Date:	23 Mar 2021	Material Risk Score:	3
Next Inspection:	23/03/2022	Material Risk Band:	Very Low
		Priority Risk Score:	6
		Priority Risk Band:	Low

Material Comments: Asbestos Bitumen sleeve (Possible continues through building)

Action Category
3

Action: Manage annually, as a minimum

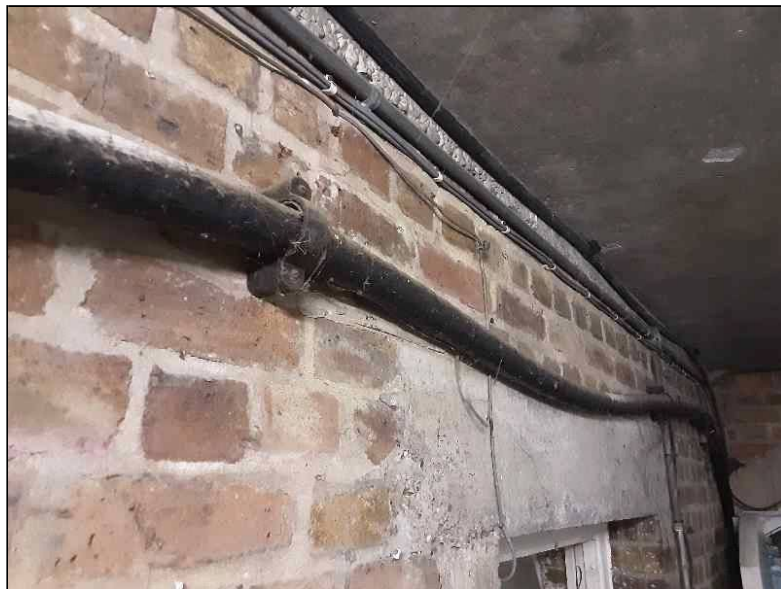
Item Ref:	3	Survey Type:	Management (MA + PA)
Sample Ref:	SO002543	Product:	Well Bound Material
Area:	Electrical cabling	Product Type:	N/A
Floor:	Z-Sub Level 1	Asbestos Type:	No Asbestos Detected
Room:	Basement Lobby & Corridor	Damage:	N/A
Surveyor Name:	Craig Chapman,	Treatment:	N/A
Identification:	Identified	Quantity:	N/A
Asbestos ?	No		
Date:	23 Mar 2021		
Next Inspection:	N/A

Material Comments:	Non Asbestos Bitumen wrap to power cable (Mains power cable is the property of electricity supply company)
--------------------	--

Action:	No further action required
---------	----------------------------

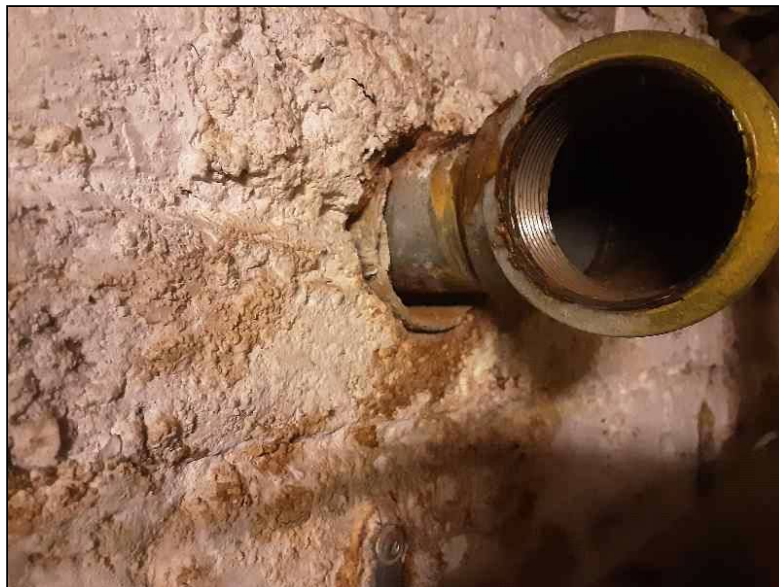
Item Ref:	4	Survey Type:	Management (MA + PA)
Sample Ref:	SO002545	Product:	Non Textiles/Paper
Area:	Other	Product Type:	N/A
Floor:	Z-Sub Level 1	Asbestos Type:	No Asbestos Detected
Room:	Store	Damage:	N/A
Surveyor Name:	Craig Chapman,	Treatment:	N/A
Identification:	Identified	Quantity:	N/A
Asbestos ?	No		
Date:	23 Mar 2021		
Next Inspection:	N/A

Material Comments: Non Asbestos Nylon sleeve

Action: No further action required

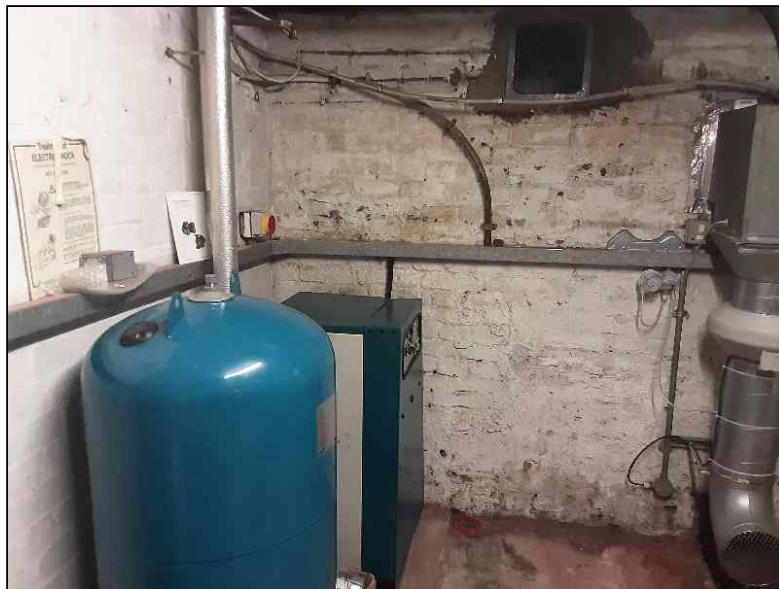
Item Ref:	8	Survey Type:	Management (MA + PA)
Sample Ref:	SO002546	Product:	Non Insulation
Area:	Wall	Product Type:	N/A
Floor:	Z-Sub Level 1	Asbestos Type:	No Asbestos Detected
Room:	Boiler room	Damage:	N/A
Surveyor Name:	Craig Chapman,	Treatment:	N/A
Identification:	Identified	Quantity:	N/A
Asbestos ?	No		
Date:	23 Mar 2021		
Next Inspection:	N/A

Material Comments: Non Asbestos Brickwork (General wall sample 16M²)

Action: No further action required

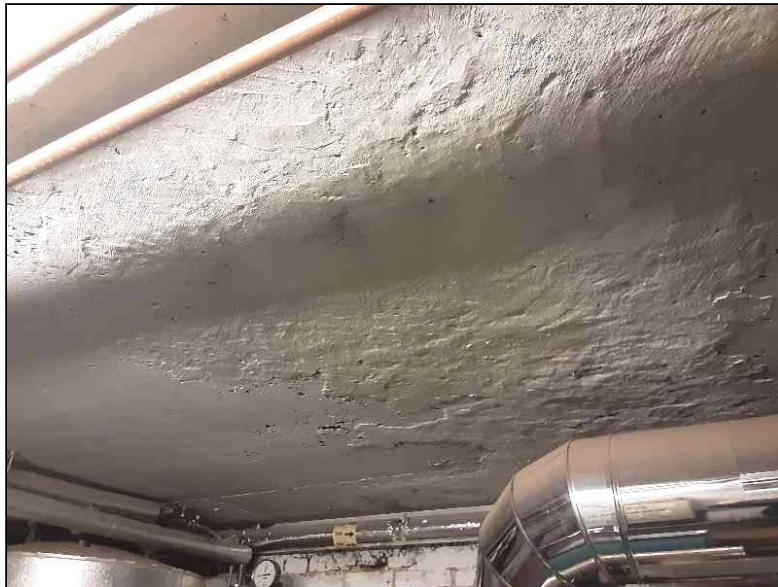
Item Ref:	9	Survey Type:	Management (MA + PA)
Sample Ref:	SO002547	Product:	Non Insulation
Area:	Ceiling	Product Type:	N/A
Floor:	Z-Sub Level 1	Asbestos Type:	No Asbestos Detected
Room:	Boiler room	Damage:	N/A
Surveyor Name:	Craig Chapman,	Treatment:	N/A
Identification:	Identified	Quantity:	N/A
Asbestos ?	No		
Date:	23 Mar 2021		
Next Inspection:	N/A

Material Comments: Non Asbestos Concrete (General ceiling sample 10MÂ²)

Action: No further action required

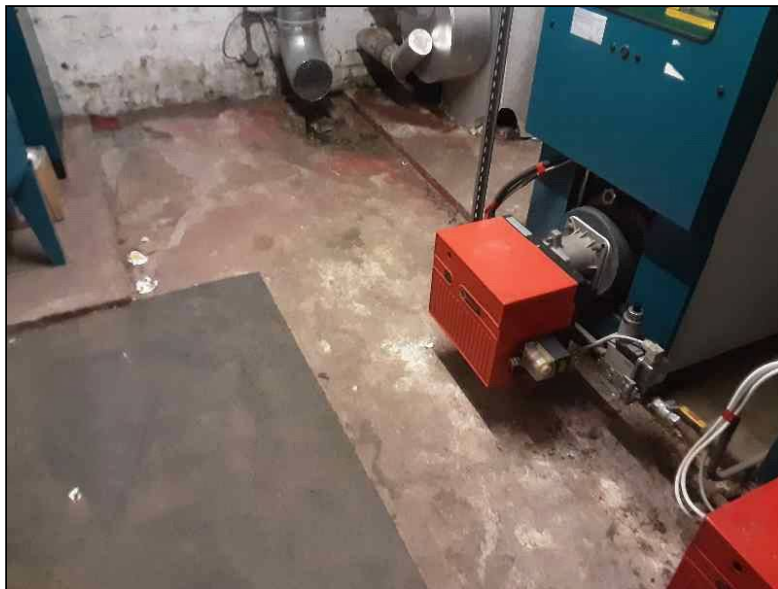
Item Ref:	10	Survey Type:	Management (MA + PA)
Sample Ref:	SO002548	Product:	Dust/Debris
Area:	Floor	Product Type:	N/A
Floor:	Z-Sub Level 1	Asbestos Type:	No Asbestos Detected
Room:	Boiler room	Damage:	N/A
Surveyor Name:	Craig Chapman,	Treatment:	N/A
Identification:	Identified	Quantity:	N/A
Asbestos ?	No

Material Comments: Non Asbestos Concrete (General floor sample 10m²)

Action: No further action required

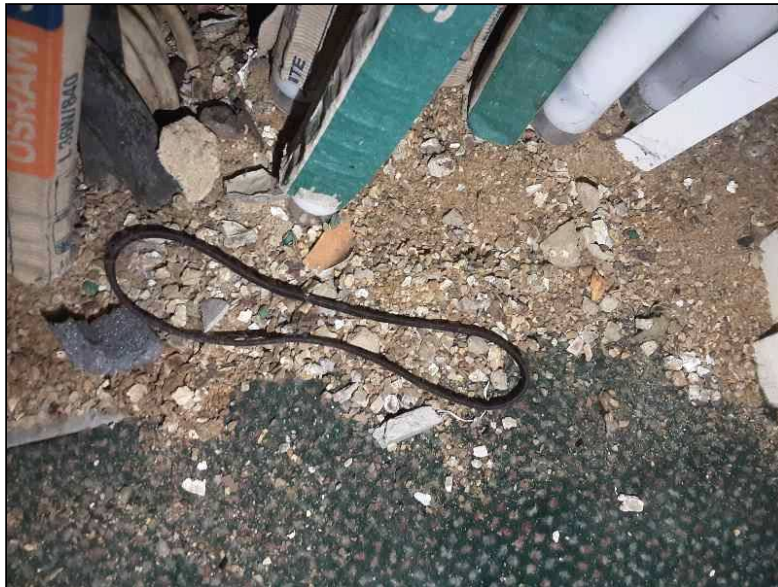
Item Ref:	23	Survey Type:	Management (MA + PA)
Sample Ref:	SO002549	Product:	Non Insulation
Area:	Other	Product Type:	N/A
Floor:	Ground Floor	Asbestos Type:	No Asbestos Detected
Room:	Intake cupboard	Damage:	N/A
Surveyor Name:	Craig Chapman,	Treatment:	N/A
Identification:	Identified	Quantity:	N/A
Asbestos ?	No		
Date:	23 Mar 2021		
Next Inspection:	N/A

Material Comments: Non Asbestos Vermiculite

Action: No further action required

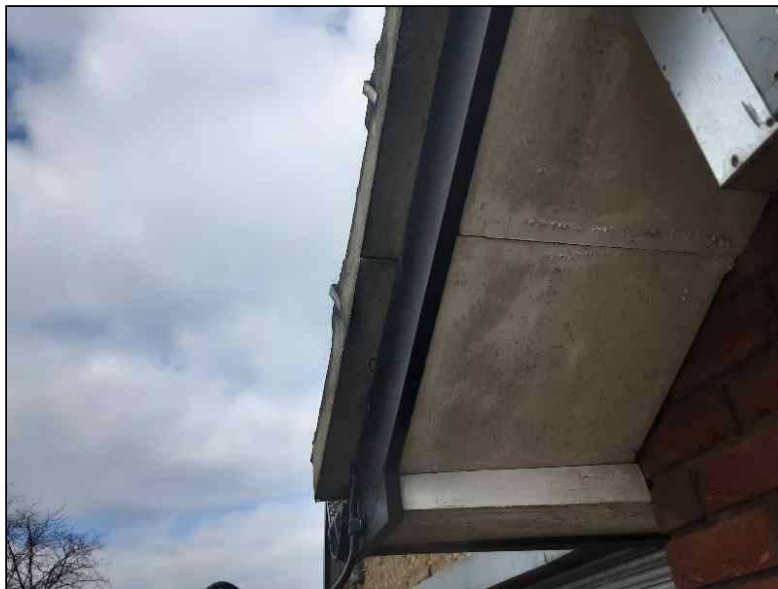
Item Ref:	25	Survey Type:	Management (MA + PA)
Sample Ref:	SO002550	Product:	Non Cement
Area:	Other	Product Type:	N/A
Floor:	External	Asbestos Type:	No Asbestos Detected
Room:	External	Damage:	N/A
Surveyor Name:	Craig Chapman,	Treatment:	N/A
Identification:	Identified	Quantity:	N/A
Asbestos ?	No		
Date:	23 Mar 2021		
Next Inspection:	N/A

Material Comments: Non Asbestos Undercloaking

Action: No further action required

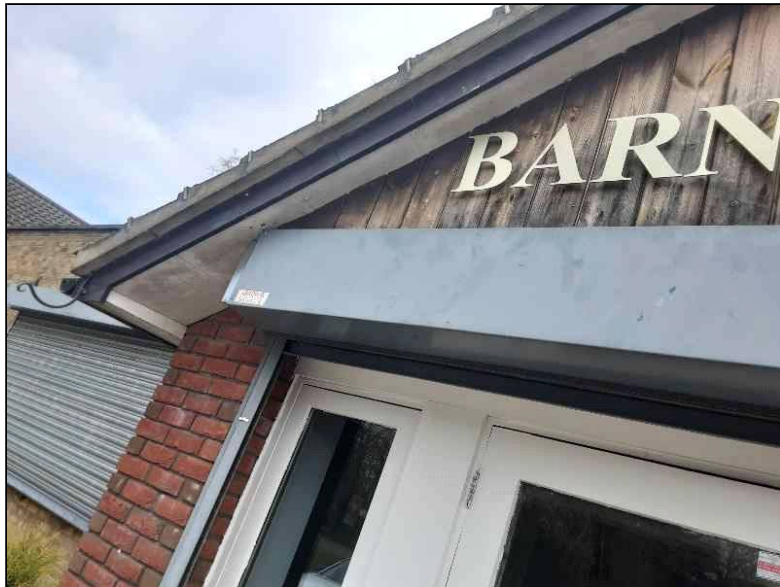
Item Ref:	26	Survey Type:	Management (MA + PA)
Sample Ref:	SO002551	Product:	Non Insulating Board
Area:	Other	Product Type:	N/A
Floor:	External	Asbestos Type:	No Asbestos Detected
Room:	External	Damage:	N/A
Surveyor Name:	Craig Chapman,	Treatment:	N/A
Identification:	Identified	Quantity:	N/A
Asbestos ?	No		
Date:	23 Mar 2021		
Next Inspection:	N/A

Material Comments: Non Asbestos Insulating board soffits

Action: No further action required

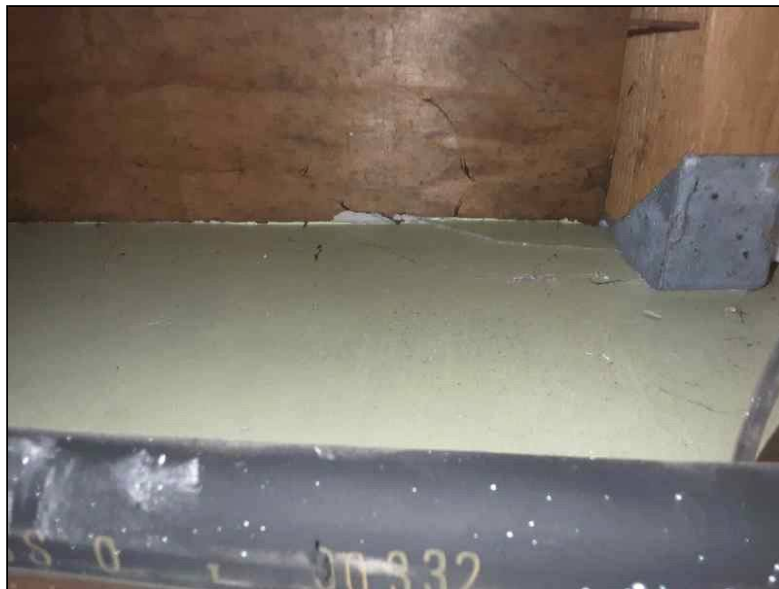
Item Ref:	27	Survey Type:	Management (MA + PA)
Sample Ref:	SO002552	Product:	Asbestos Insulating Board
Area:	Other	Product Type:	Medium Fibre Release
Floor:	Ground Floor	Asbestos Type:	Chrysotile
Room:	Reception	Damage:	Medium Damage
Surveyor Name:	Craig Chapman,	Treatment:	Unsealed Insulating Board
Identification:	Identified	Quantity:	Throughout
Asbestos ?	Yes		
Date:	23 Mar 2021		
Next Inspection:	23/03/2022

Material Risk Score:	7	Action Category 3
Material Risk Band:	Medium	
Priority Risk Score:	5	
Priority Risk Band:	Medium

Material Comments: Asbestos Paper insulation above suspended ceiling between timber ceiling and wall (Possible located throughout building area to this nature of the same ceiling and walls. 100lm or more)

Action: Apply warning labels & plan removal as soon as practicable

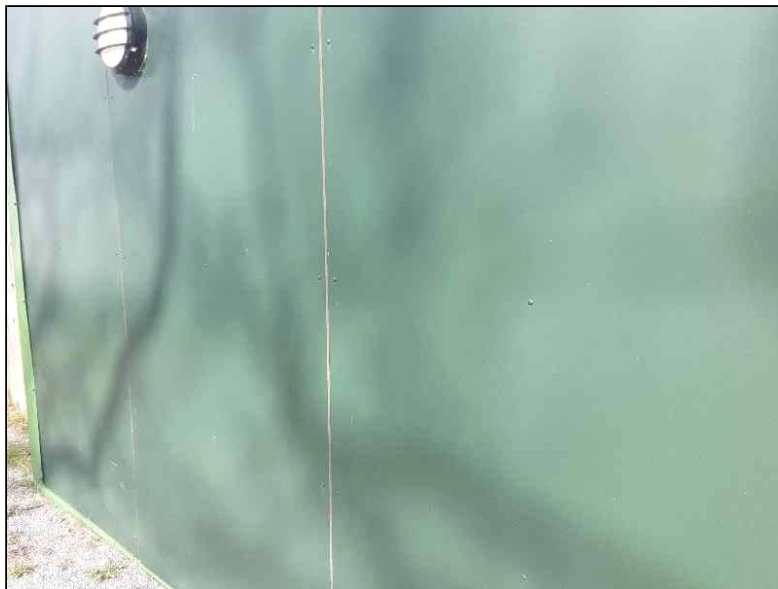
Item Ref:	38	Survey Type:	Management (MA + PA)
Sample Ref:	SO002553	Product:	Non Insulating Board
Area:	Walls	Product Type:	N/A
Floor:	Ground Floor	Asbestos Type:	No Asbestos Detected
Room:	Driving range	Damage:	N/A
Surveyor Name:	Craig Chapman,	Treatment:	N/A
Identification:	Identified	Quantity:	N/A
Asbestos ?	No		
Date:	23 Mar 2021		
Next Inspection:	N/A

Material Comments: Non Asbestos Modern insulating board panels (internal and external)

Action: No further action required

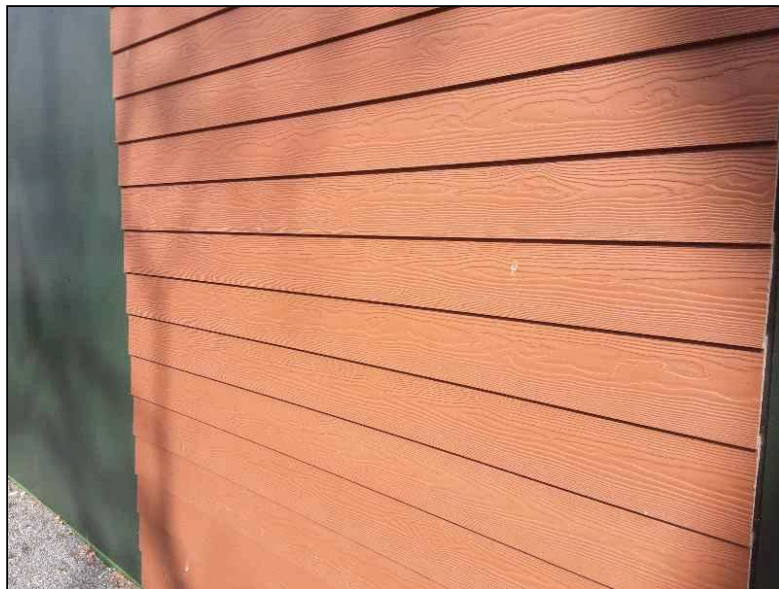
Item Ref:	39	Survey Type:	Management (MA + PA)
Sample Ref:	SO002554	Product:	Non Cement
Area:	Walls	Product Type:	N/A
Floor:	Ground Floor	Asbestos Type:	No Asbestos Detected
Room:	Driving range	Damage:	N/A
Surveyor Name:	Craig Chapman,	Treatment:	N/A
Identification:	Identified	Quantity:	N/A
Asbestos ?	No		
Date:	23 Mar 2021		
Next Inspection:	N/A

Material Comments:	Non Asbestos External cladding to walls
--------------------	---

Action:	No further action required
---------	----------------------------

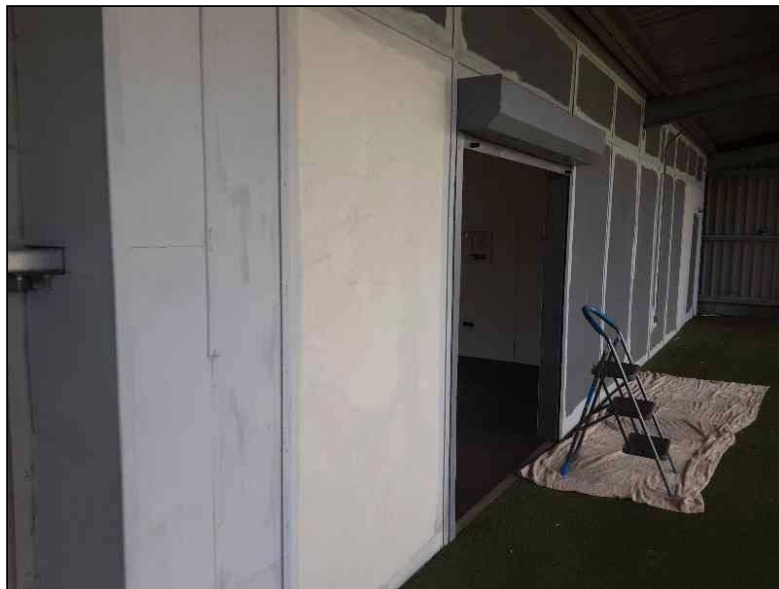
Item Ref:	40	Survey Type:	Management (MA + PA)
Sample Ref:	As SO002553	Product:	Non Insulating Board
Area:	Walls	Product Type:	N/A
Floor:	Ground Floor	Asbestos Type:	No Asbestos Detected
Room:	Driving range	Damage:	N/A
Surveyor Name:	Craig Chapman,	Treatment:	N/A
Identification:	Strongly Presumed	Quantity:	N/A
Asbestos ?	No		
Date:	23 Mar 2021		
Next Inspection:	N/A

Material Comments: Non Asbestos Modern insulating board (internal and external)

Action: No further action required

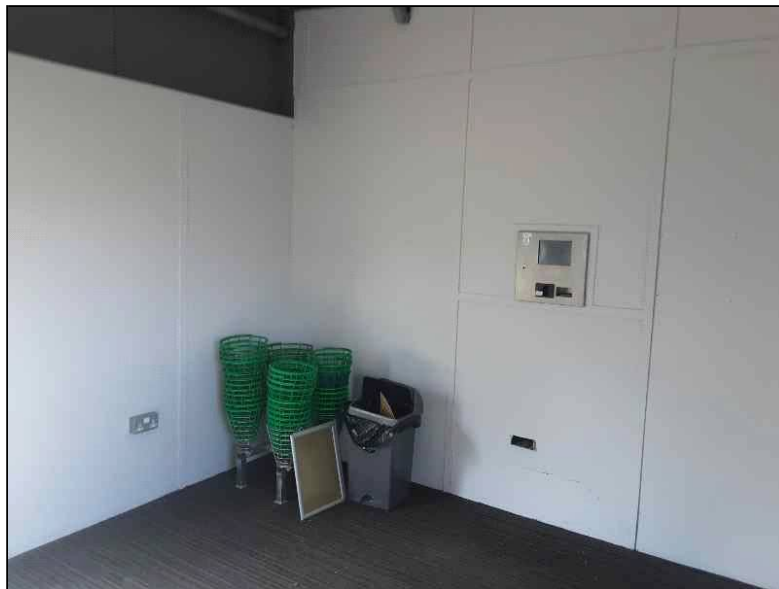
Item Ref:	41	Survey Type:	Management (MA + PA)
Sample Ref:	As SO002553	Product:	Non Insulating Board
Area:	Walls	Product Type:	N/A
Floor:	Ground Floor	Asbestos Type:	No Asbestos Detected
Room:	Driving range	Damage:	N/A
Surveyor Name:	Craig Chapman,	Treatment:	N/A
Identification:	Strongly Presumed	Quantity:	N/A
Asbestos ?	No		
Date:	23 Mar 2021		
Next Inspection:	N/A

Material Comments: Non Asbestos Modern insulating board (internal and external)

Action: No further action required

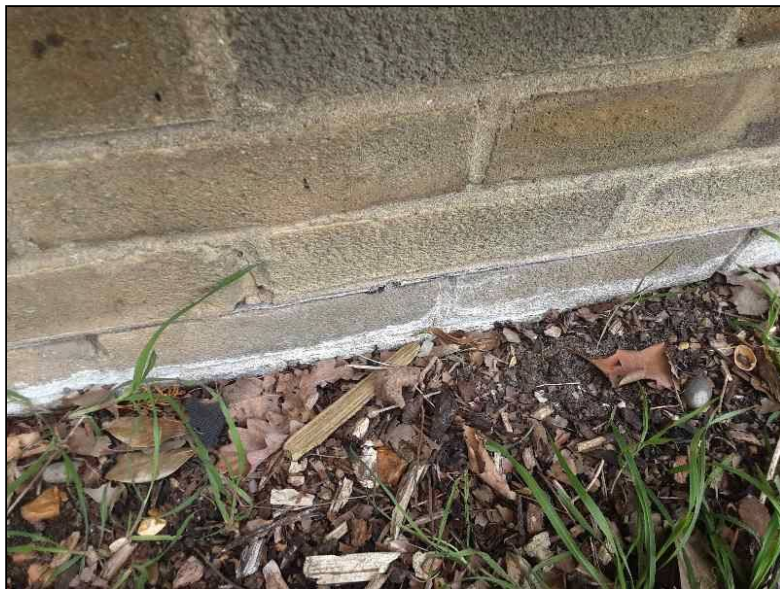
Item Ref:	42	Survey Type:	Management (MA + PA)
Sample Ref:	SO002555	Product:	Well Bound Material
Area:	Other	Product Type:	Low Fibre Release
Floor:	External	Asbestos Type:	Chrysotile
Room:	External	Damage:	Low Damage
Surveyor Name:	Craig Chapman,	Treatment:	Damp proof course
Identification:	Identified	Quantity:	80lm
Asbestos ?	Yes		
Date:	23 Mar 2021		
Next Inspection:	23/03/2022

Material Risk Score:	3	<div style="background-color: green; color: white; padding: 10px; font-weight: bold; font-size: 1.2em;"> Action Category 4 </div>
Material Risk Band:	Very Low	
Priority Risk Score:	2	
Priority Risk Band:	Very Low

Material Comments: Asbestos Damp proof course

Action: Manage annually, as a minimum
